# Manhole Inspection Summary

Manhole # S33WW\_019MH

Insp Date: **4/13/07 1:28 PM**

**Location** Address: **3040 LOVEGROVE ST**

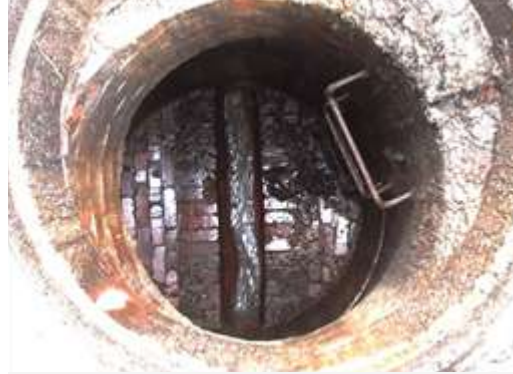
Top View

**Bench** ☒ Exists Material: **Brick** ☐ Parged ☒ **Debris** (not Condition related)

**Surcharge** ☒ **Evidence Of Surcharge** Depth: **1** (ft.) ☐ Active Surcharge Present

Evidence of surcharge - Bench debris.

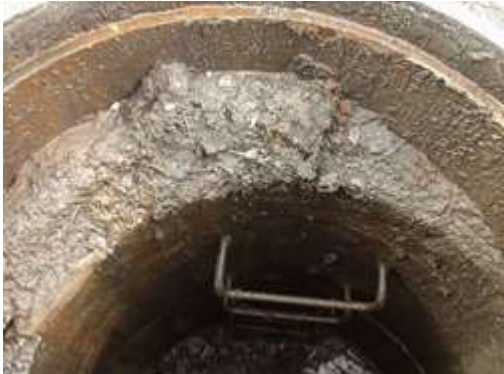
Defect

**Frame** Offset: **4** (in.)

☒ **Leaks**

Condition: ☐ Sound ☐ Cracked ☐ Root Intrusion ☒ **Loose Brick** ☒ **Deteriorated**

Infiltration: ☐ None ☒ **Joint** ☐ Cracks ☒ **Mortar** ☐ Roots ☐ Wall

Frame leaks. Frame offset. Adjustment deterioration, loose brick and infiltration - other side.

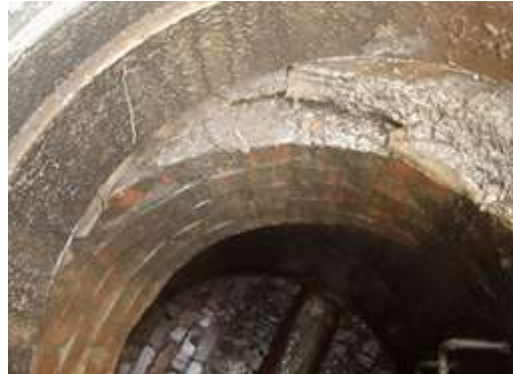
Defect

Infiltration: ☐ None ☒ **Joint** ☐ Cracks ☐ Mortar ☐ Roots ☐ Wall

Frame leaks. Frame offset. Adjustment deterioration, loose brick and infiltration. Corbel and Barrel infiltration.

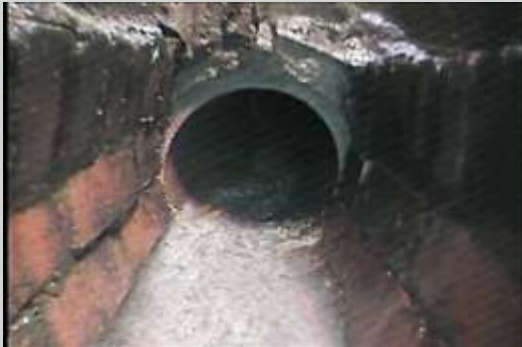
### 8 in. Circular Gravity Sewer Pipe Out @ 12 O'Clock

Rod and Bar (Angled)

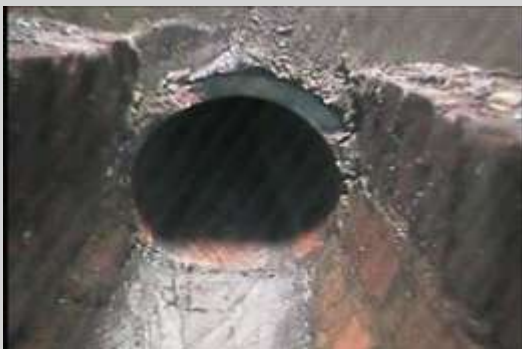
### 8 in. Circular Gravity Sewer Pipe In @ 6 O'Clock

Rod and Bar (Angled)
